21 March 1965

Page 23DUAL HEN HOUSE-TYPE STRUCTURE

OLENEGORSK, USSR

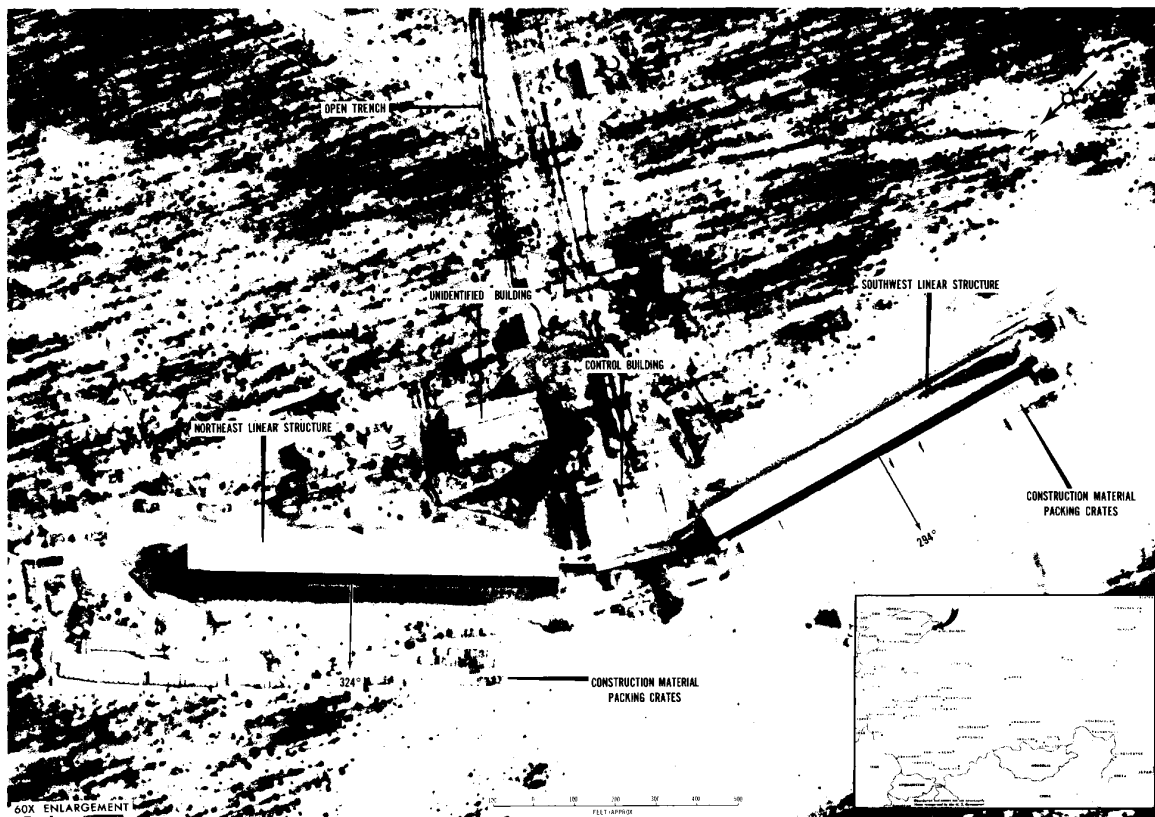
DUAL HEN HOUSE-TYPE STRUCTURE
OLENEGORSK, USSR
68-06N 33-55E

THE OPERATIONS AREA CONSISTS OF A CENTRAL CONTROL BUILDING AND A LINEAR STRUCTURE ON EITHER SIDE OF AND CANTED TO THE CONTROL BUILDING

FORMING A BOWED PATTERN AT AN ANGLE OF APPROXIMATELY 150/210 DEGREES. THE NE LINEAR STRUCTURE IS ORIENTED NE/SW WITH THE ANTENNA FACING TOWARD AN AZIMUTH OF APPROXIMATELY [REDACTED] THE SW LINEAR STRUCTURE IS ORIENTED NNW/SSW WITH THE ANTENNA FACING AN AZIMUTH OF APPROXIMATELY [REDACTED]
